# A83 Trunk Road Widening Scheme - Case Study

Ian Farmer Associates were commissioned by Scotland Transerv, acting on behalf of Transport Scotland, to undertake a ground investigation for the proposed widening of the A83 trunk road. The section of the route was approximately 2km in length. The site operations required Traffic Safety provisions and the production of an Environmental Management Plan.

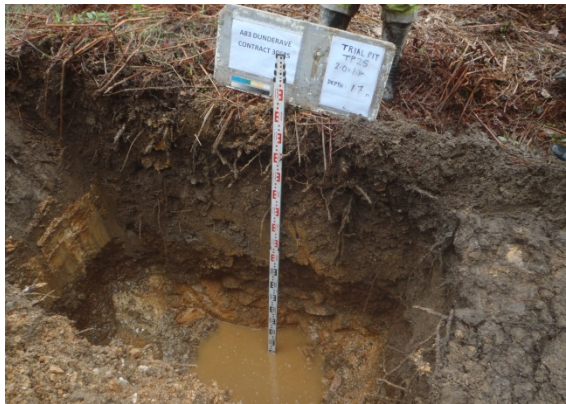
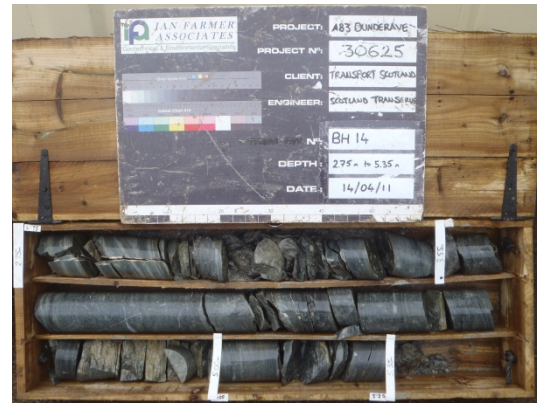
Trial pits were dug by mechanical excavator and hand vane readings were obtained. Photographs of the trial pit excavations and rock core were taken
