Condition Investigation – Case Study

A1 Structures

Ian Farmer Associates were appointed by a national contractor to carry out concrete condition surveys on four bridges situated within the A1 Dishforth to Barton improvement scheme.

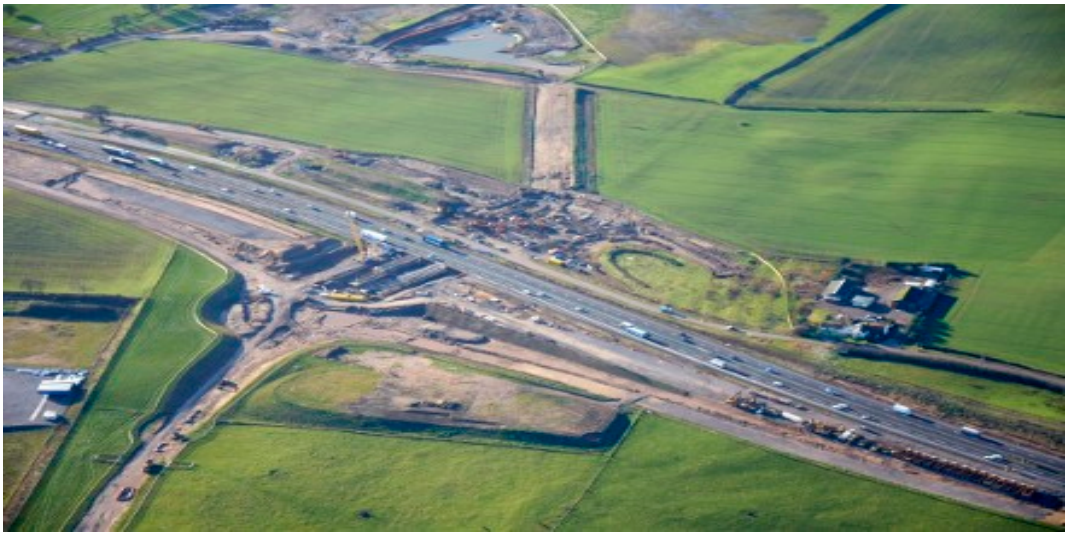
The survey consisted of destructive and non-destructive testing of the bridge decks and soffit.

Survey works included a full delamination and soundness survey, full half cell potential survey, full cover meter survey, resistivity survey, carbonation depth and selective locations for dust sampling which depended on half cell potential readings.

Reports were issued to the client to assist in the remediation works on each bridge surveyed.
